## **ANSETT VISCOUNT CATCHES FIRE AND BREAKS UP IN MID-AIR. ALL 24 KILLED**

### **Investigation and Board of Accident Inquiry**

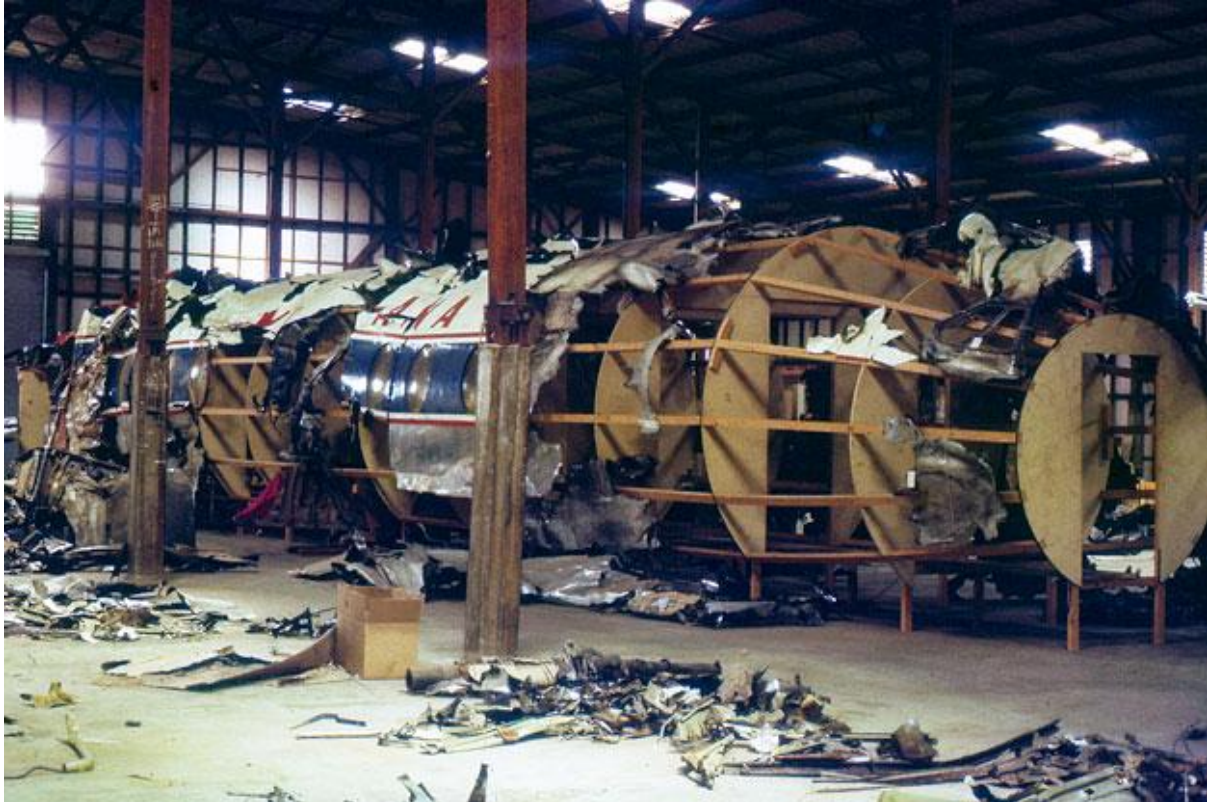
Reconstruction of VH-RMI in a Footscray wool shed

*The means of securing the oil metering unit to the no 2 cabin blower became ineffective and this led to the initiation of a fire within the blower, which propagated to the wing fuel tank and substantially reduced the strength of the main spar upper boom. It is probable that the separation of the oil metering unit arose from an out-of-balance condition induced by rotor break-up but the source of the rotor break-up could not be determined.*

The Inquiry first sat on 26 April and concluded on 31 August 1967. Its findings mirrored those of the investigators' Report. There was a recommendation that Cockpit Voice Recorders be installed in all commercial aircraft weighing over 12,500 lbs, in addition to the Flight Data Recorder.
