**AUSTRALIA'S WORST AIR CRASH IN 1960. CAUSE INCONCLUSIVE. MAIL  
RECOVERED**

The TAA Fokker F-27 VH-TFB *Abel Tasman* was on regular passenger flight 538 from Brisbane to Mackay via Maryborough and Rockhampton on 10 June 1960. Captain Frank C Pollard and First Officer G Davis were accompanied by hostesses K Wilmer and J Hamilton.

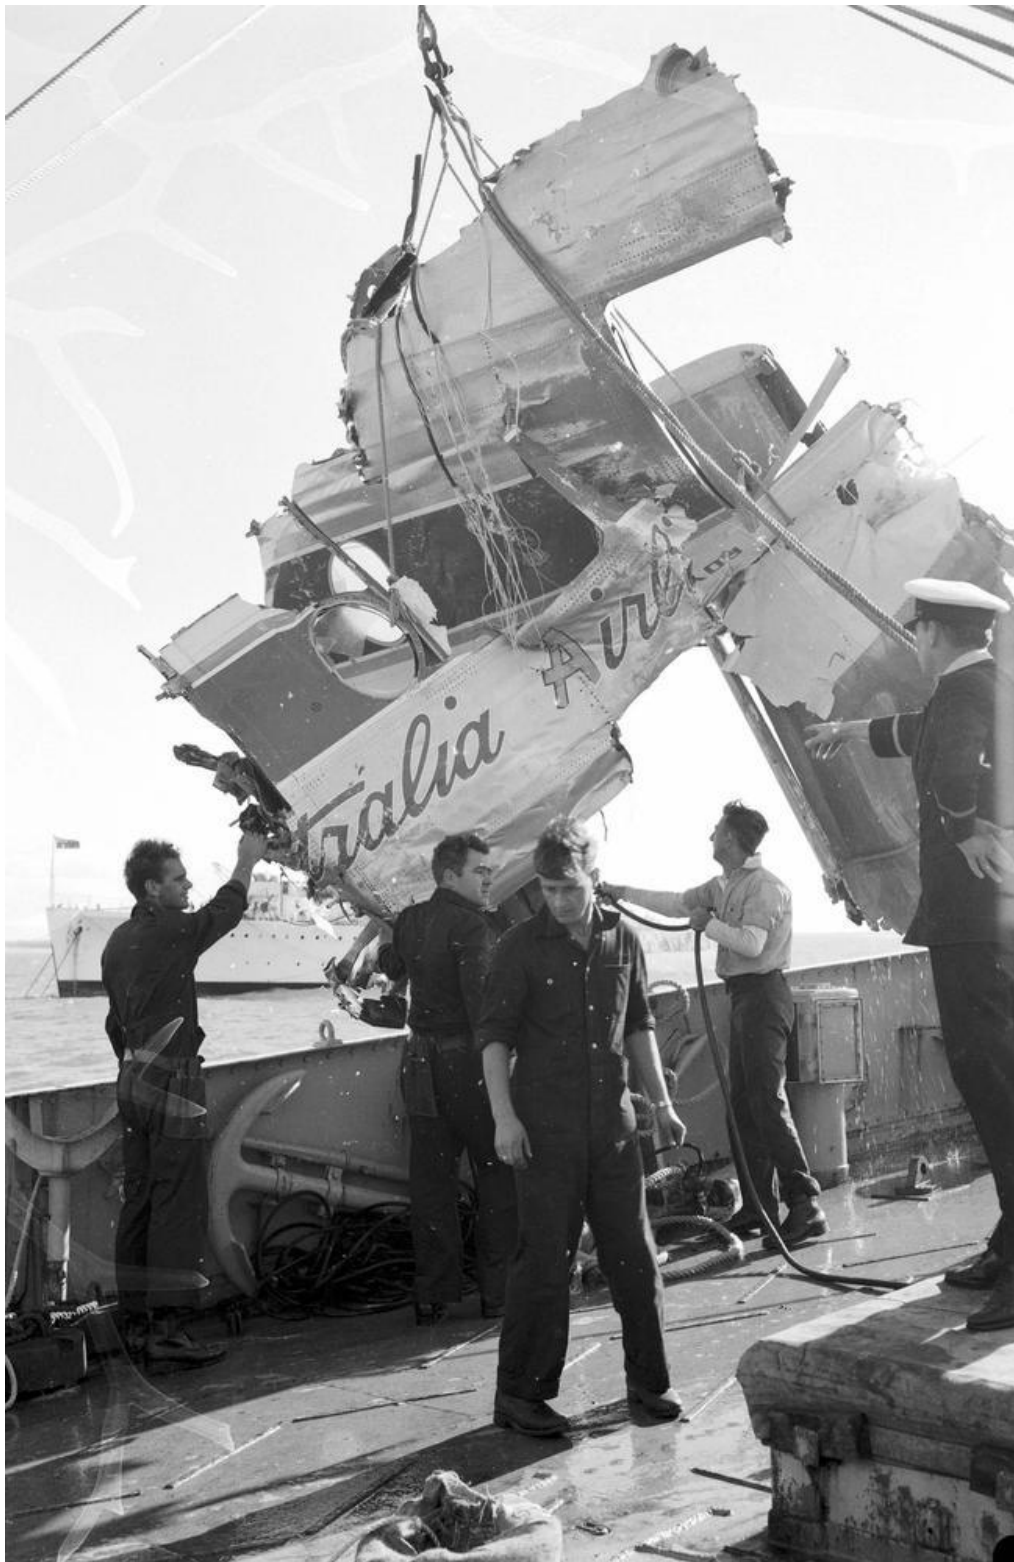
Recovery of wreckage of VH-TFB *Abel Tasman* by HMAS Warrego

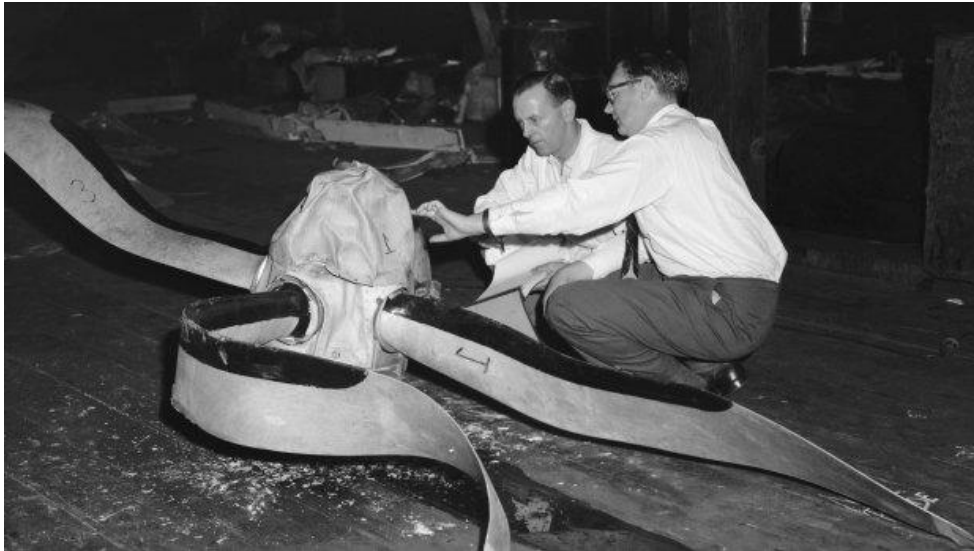
Examining wreckage in a shed at Mackay Harbour
